Evaluation of Canal Lining Projects in the Lower Rio Grande Valley

Texas Water Resources Institute Technical Report
July 2009

EVALUATION OF CANAL LINING PROJECTS IN THE LOWER RIO GRANDE VALLEY OF TEXAS

June 29, 2009

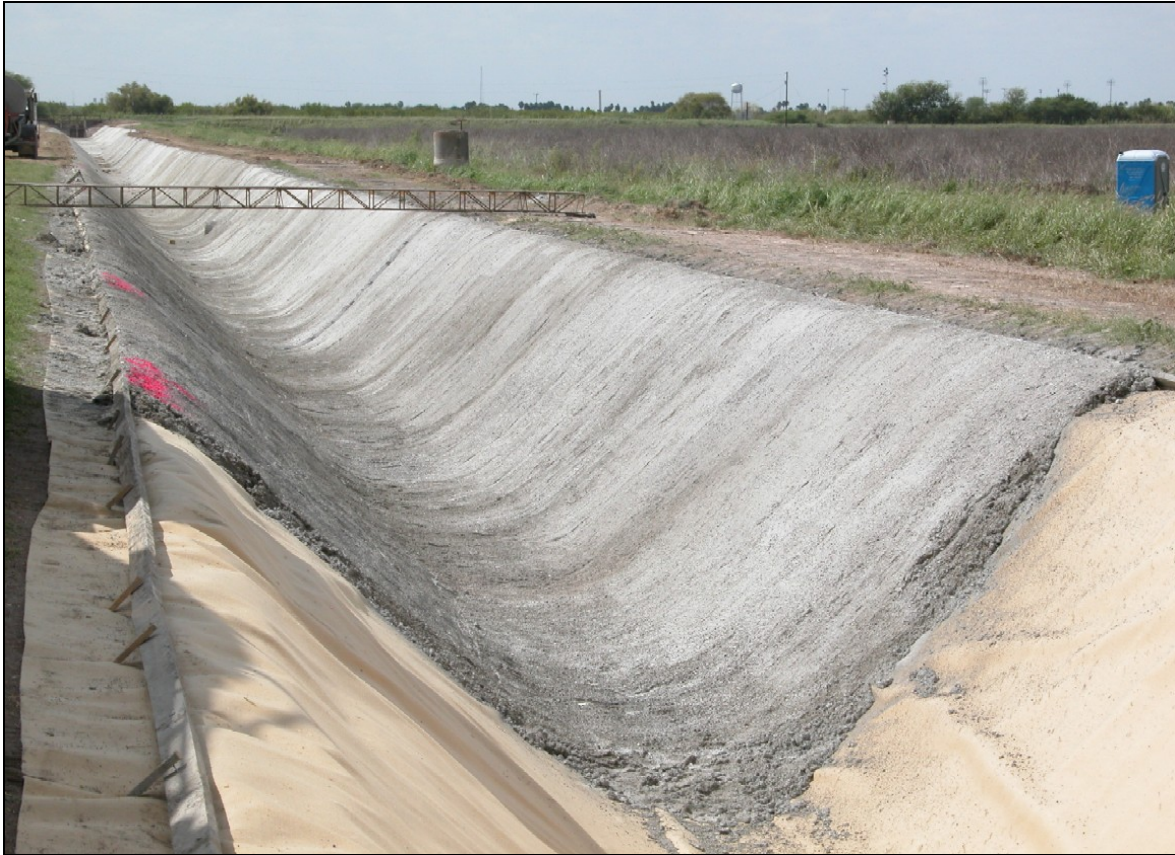
To-date, these projects show no evidence of problems and have required no maintenance. No difference in performance was observed between the two types of liners. Hairline cracks developed in the shotcrete on a small stretch of Project #5, but no related problems have been observed.

Figure 2. Polyester canal liner with a 3-inch protective barrier of shotcrete overlaid.

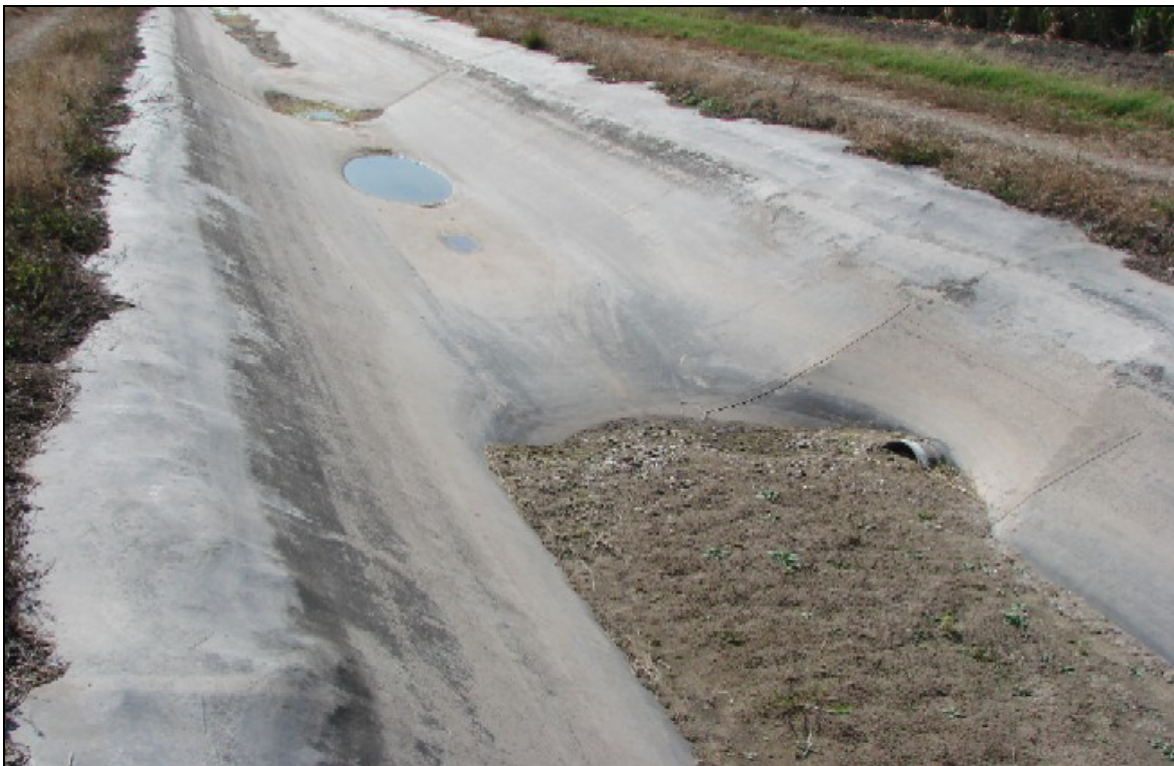
Installation and maintenance of the liners also appears to explain some of the variation in performance of these projects as discussed below. Another consideration with exposed liners is the potential damage that machinery can cause during normal district mowing operations and while cleaning out aquatic vegetation and sedimentation (Fig. 3).

Figure 3. Aquatic vegetation and sedimentation clogging a farm outlet pipe.

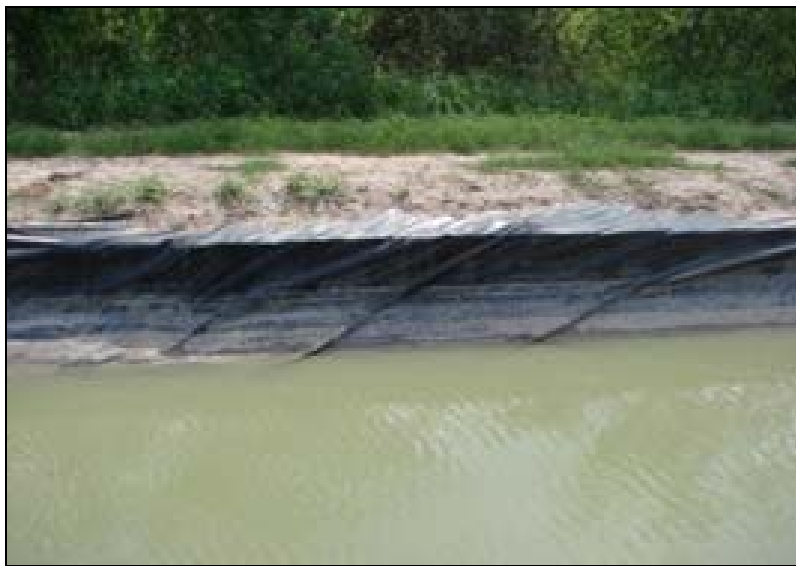
In two lining projects, polypropylene was applied on existing concrete canals (Project 4 and 9). To-date, these two lining projects are in excellent condition, with no visual damage. While Project 9 was also given a rating of excellent, we have concerns with the large amount of wrinkles which occurred during installation (Fig. 4). Wrinkles can reduce water flow, accelerate sedimentation, and provide loose material that can easily be damaged.

Figure 4. Wrinkles in a polypropylene liner from improper installation.

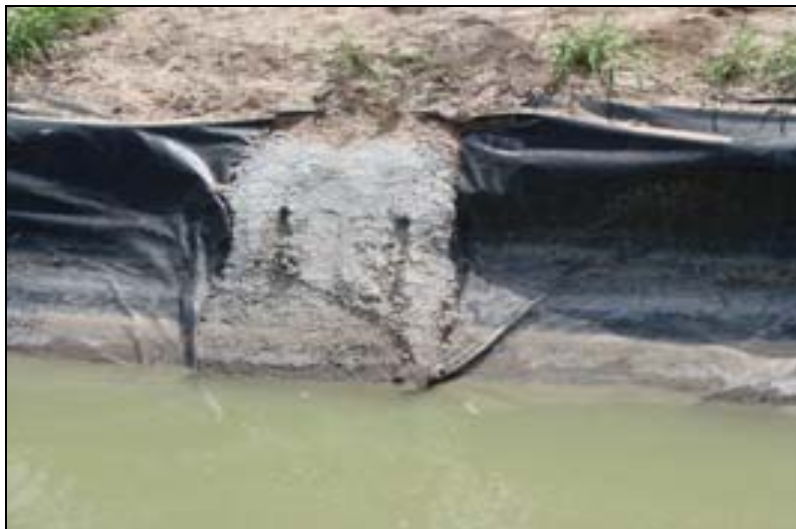
In Project 9, concrete sections approximately 1-foot wide were poured on top of the liner at a spacing of 500 feet (Fig. 5). The rationale is that the concrete sections will help keep the liner in place and provide access points for sediment removal. Our conclusion is that long-term evaluation is needed to determine if such sections are useful for these purposes.

Figure 5. Concrete sections poured on top of a polypropylene liner.

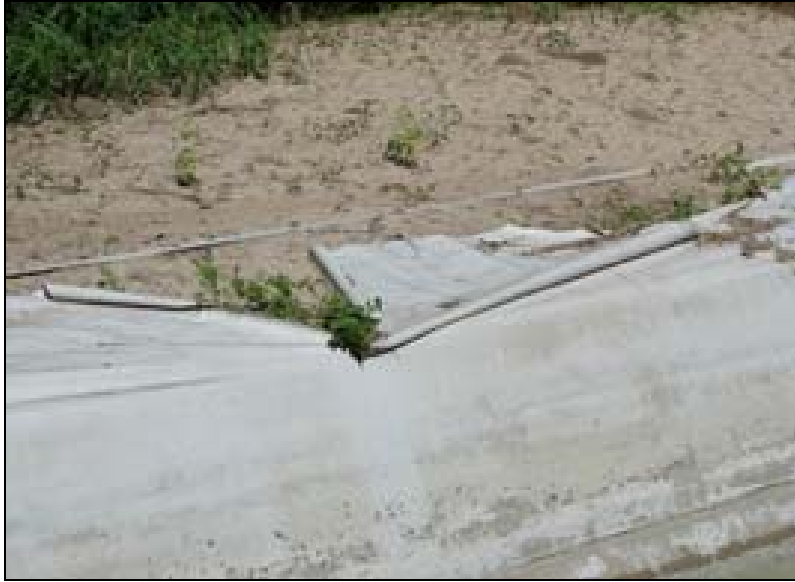
Three short sections of PVC alloy were installed in 1999 (Projects: 16, 22, 24), ranging in length from 38 to 148 ft. This material has performed well, requiring little maintenance, with no major damage observed. However, cuts and tears have occurred in the exposed area of the liner (Fig. 6) which could develop into larger problems if not taken care of in a timely manner. The overall performances for these small test segments are excellent to good. A section in excellent shape is shown in Figure 7.

Figure 6. PVC Alloy liner damaged on the exposed area.

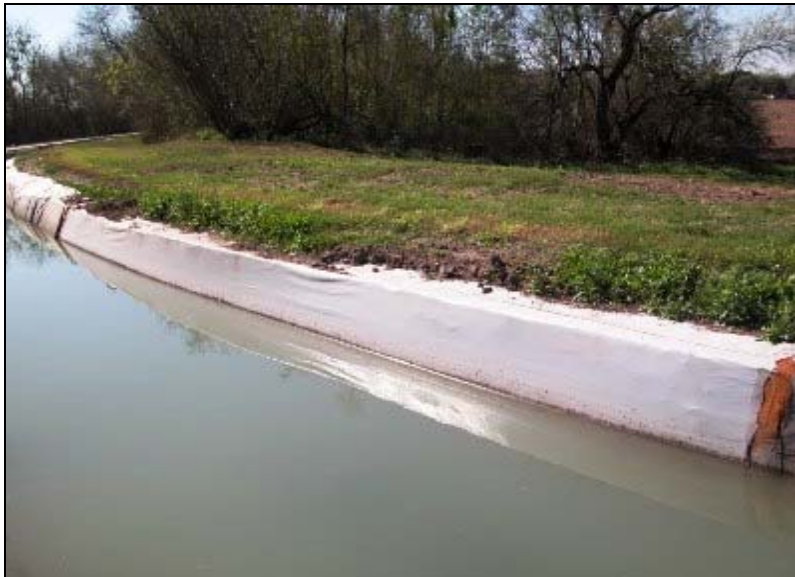
Figure 7. PVC Alloy lining segment in excellent condition.

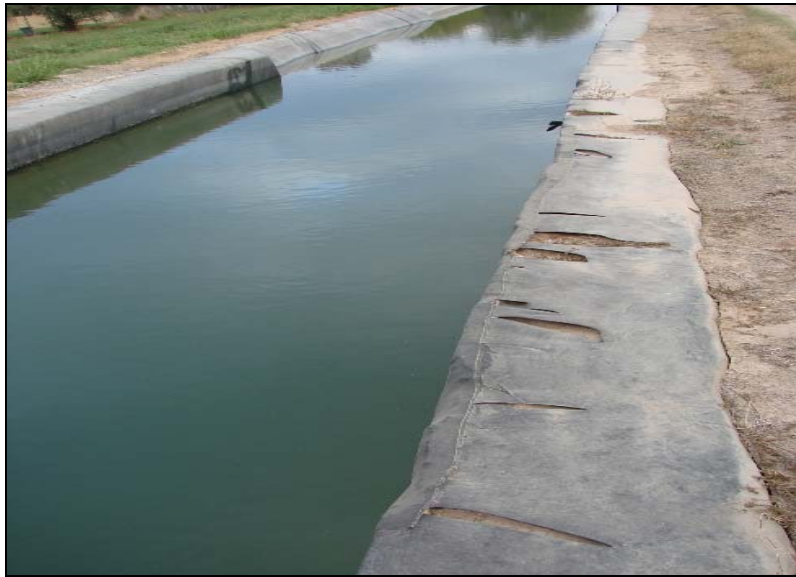
The performance of the eight (8) projects using EPDM rubber has varied significantly. Two projects are in good to excellent condition (Project 13 and 1), while the remaining six (6) range from fair condition to serious problems, with one totally failing. EPDM rubber is very susceptible to vandalism and punctures caused by animals. It also appears that many cuts and tears initially occurred on the exposed areas where there is the most human and animal traffic (Fig. 8). Unless repaired in a timely manner, these tears may lead to increasing amounts of damage (Fig. 9).

Figure 8. Cuts/tears in a rubber liner.

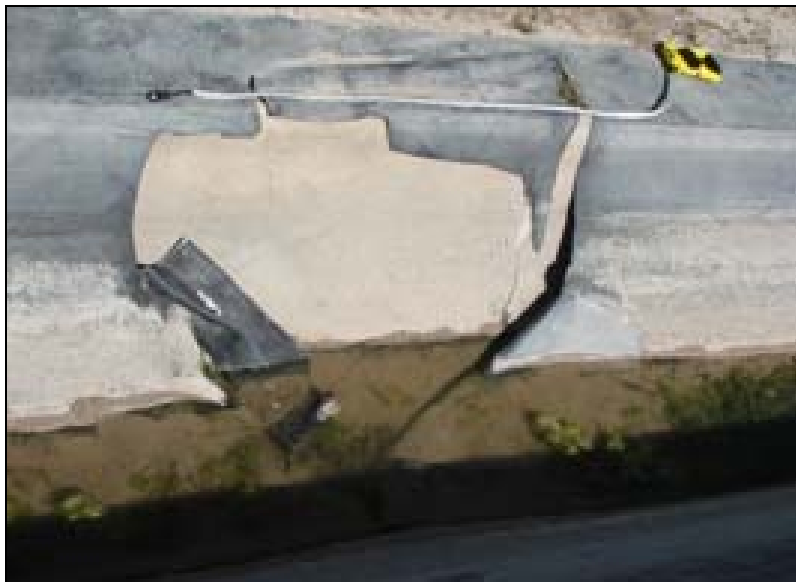
Figure 9. A rubber liner damaged possibly due to vandalism.

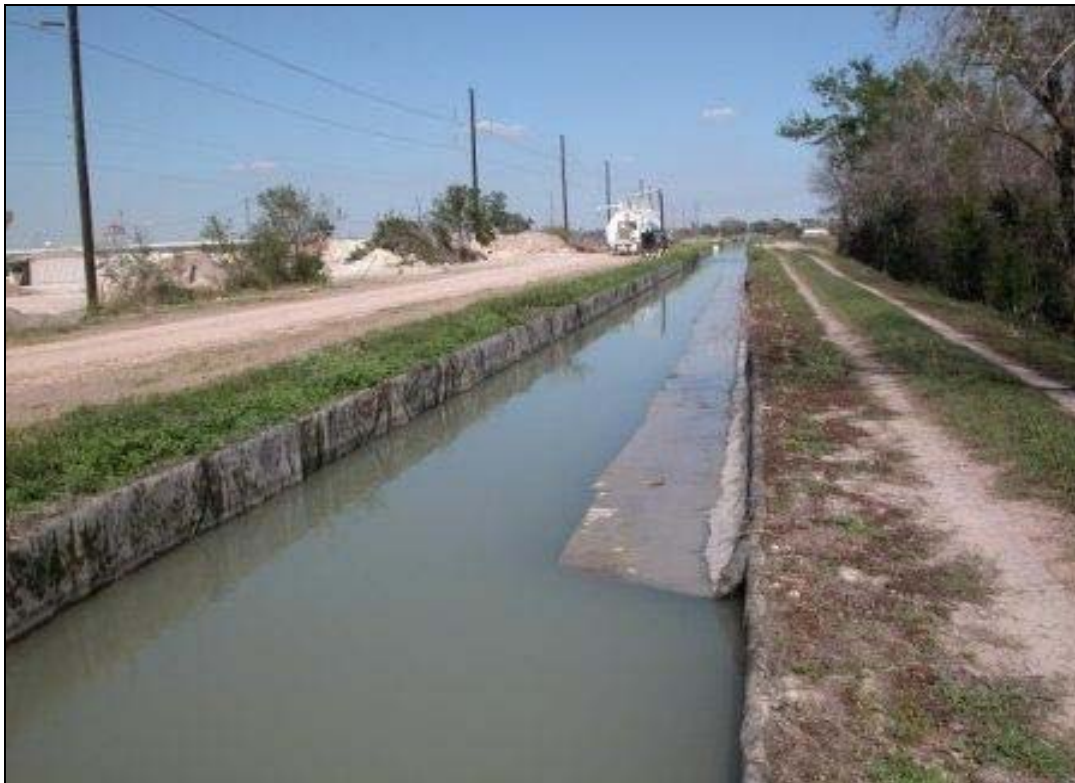
During 1999 - 2000, nine (9) short sections were lined with polyurethane (projects: 6, 10, 11, 17, 18, 20, 21, 23, and 25), totaling 1.42 miles. The current condition of these projects varies from excellent to serious problems, with one section a total failure. Observed problems include the liner falling off the canal walls which was likely caused by a combination of severe UV damage, material defects, and vandalism (Fig. 10 and 11). In some segments, the top layer of the material has peeled off, while in others, the entire liner has worn off (Fig. 12). Figure 13 shows one lining project where the polyurethane project is still in great shape.

Unlike the other liners, the polyurethane was manufactured on-site by specialized machinery, and requires that the chemicals used to be properly handled. Several problems occurred during its manufacture and installation, including inconsistency in product thickness, which may account for the large variation in performance. In addition, little to no maintenance has occurred since installation.

Figure 10. Polyurethane lining is material shown detached from the canal.

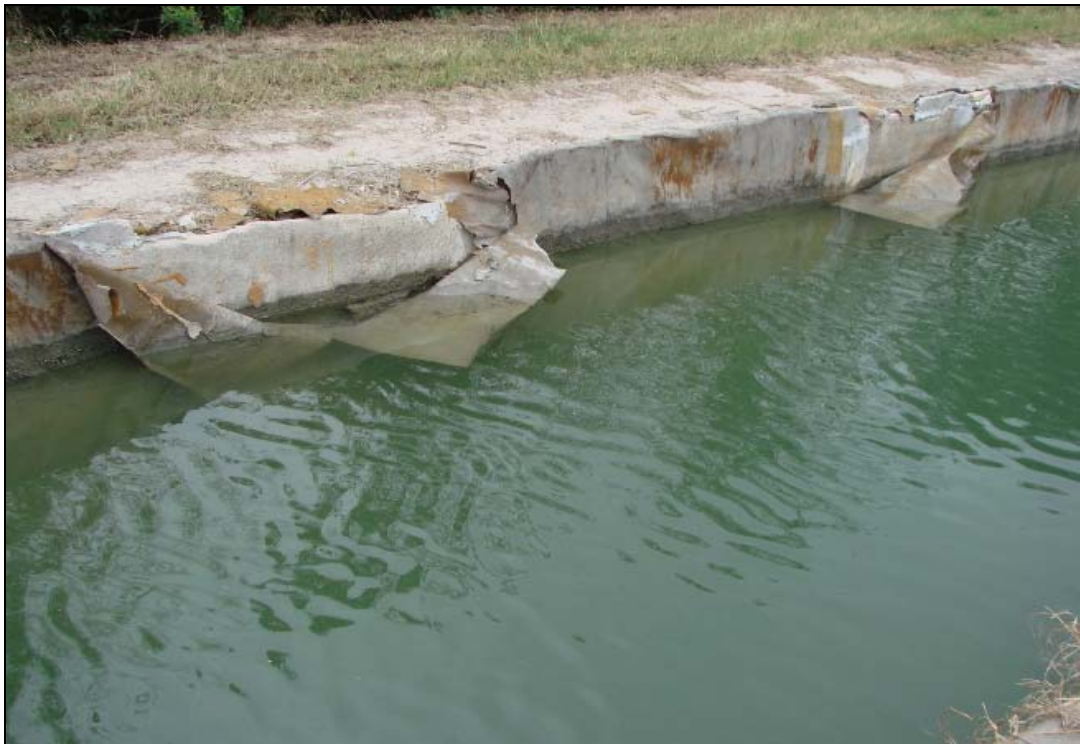
Figure 11. Polyurethane liner is shown hanging off the canal wall.

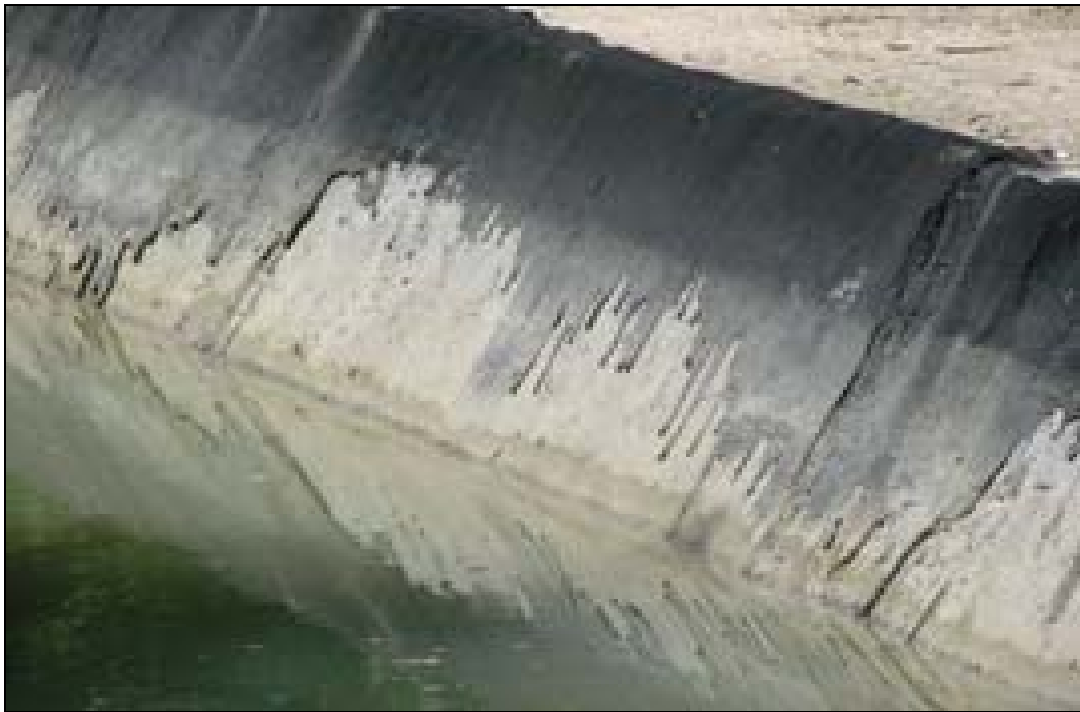
Figure 12. Residue left from a deteriorated polyurethane liner.

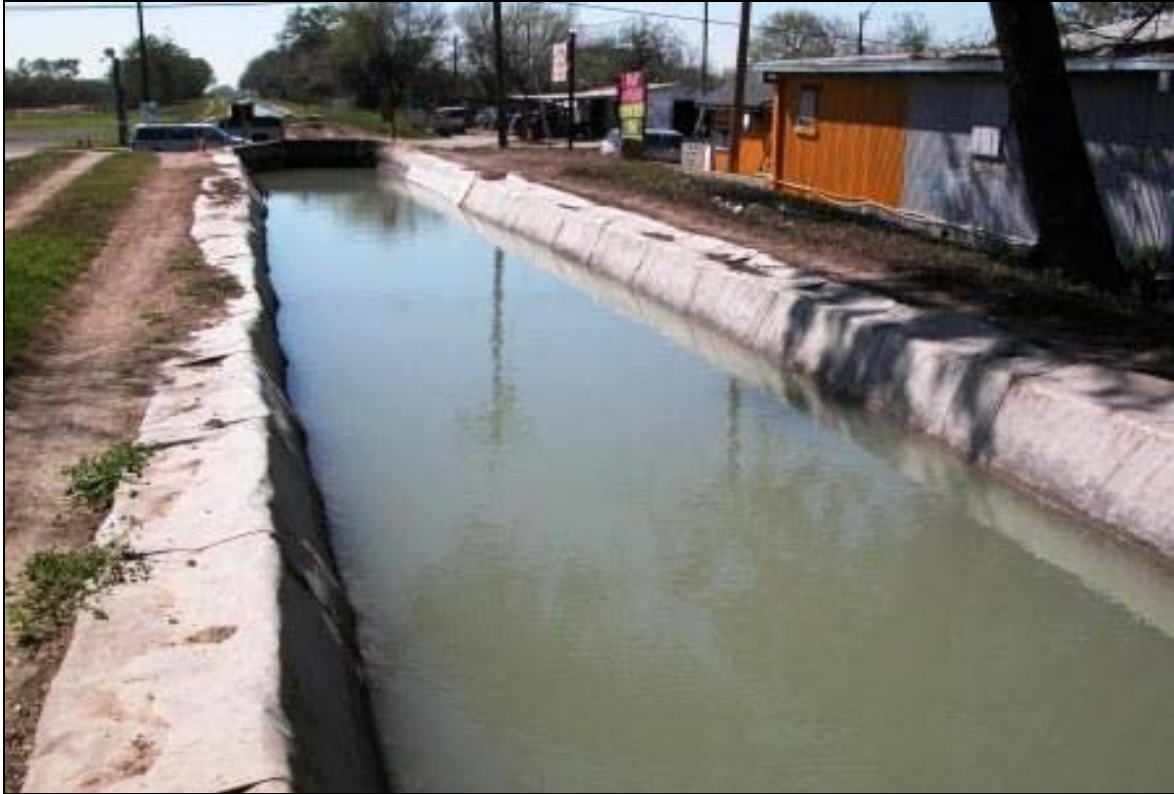
Figure 13. One polyurethane lined segment in excellent condition after 8 years of use.

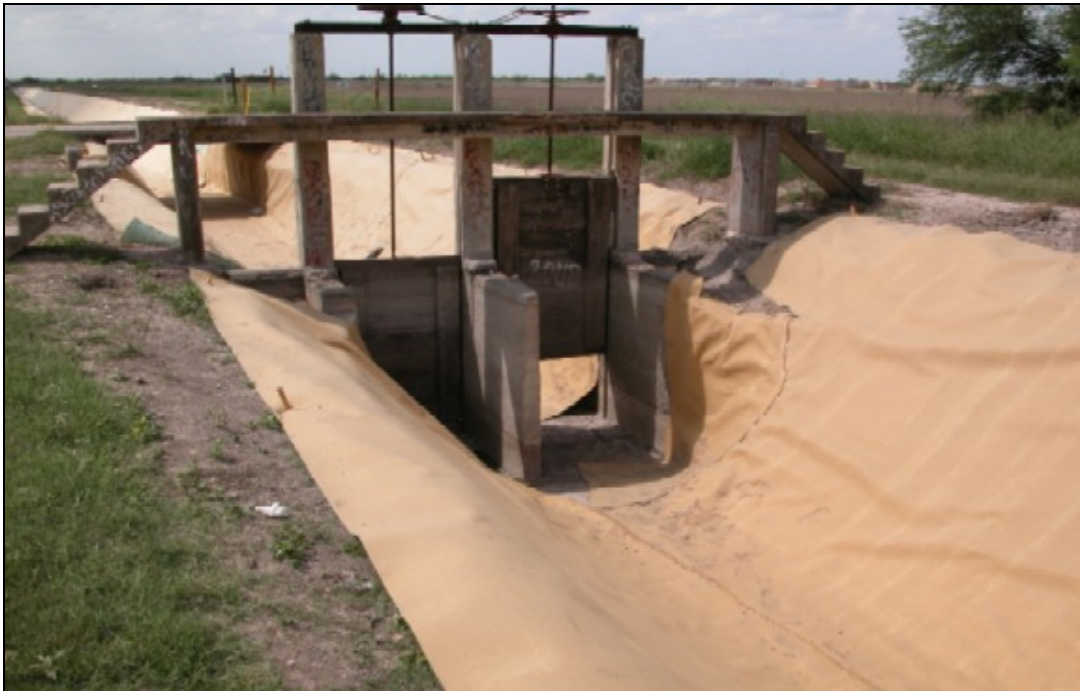
Figure 15. Improper installation of a polyester liner around a gate structure.

Liners need to be properly installed and stretched in order to prevent wrinkles. Wrinkles not only look unprofessional, but make the liner more susceptible to damage. Glues, liquid rubbers

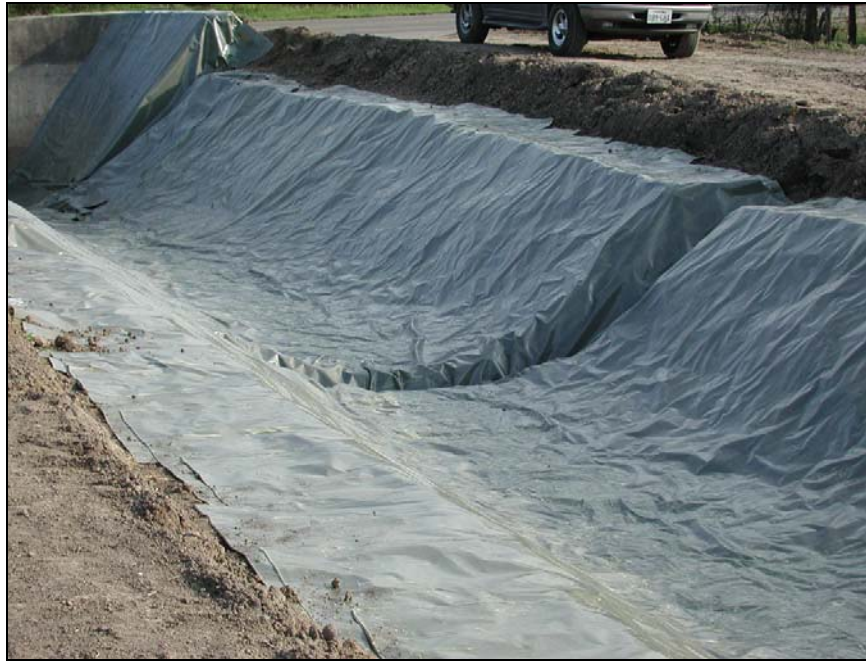
In one of early lining projects, the liner size was not planned properly to overlap and extend onto the top of the levee (Fig. 16). As seen in Figure 17, the operating depth of the canal was higher than the top of the liner. The water eventually got underneath this liner and caused it to float.

Figure 16. Canal liner installed too low on the levee.

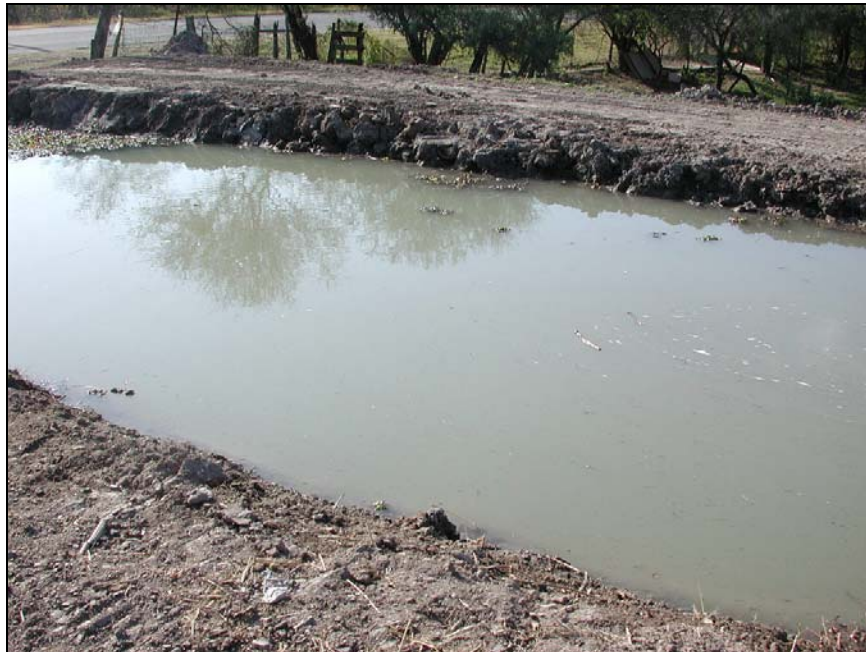
Figure 17. Water level higher than the canal liner installed.

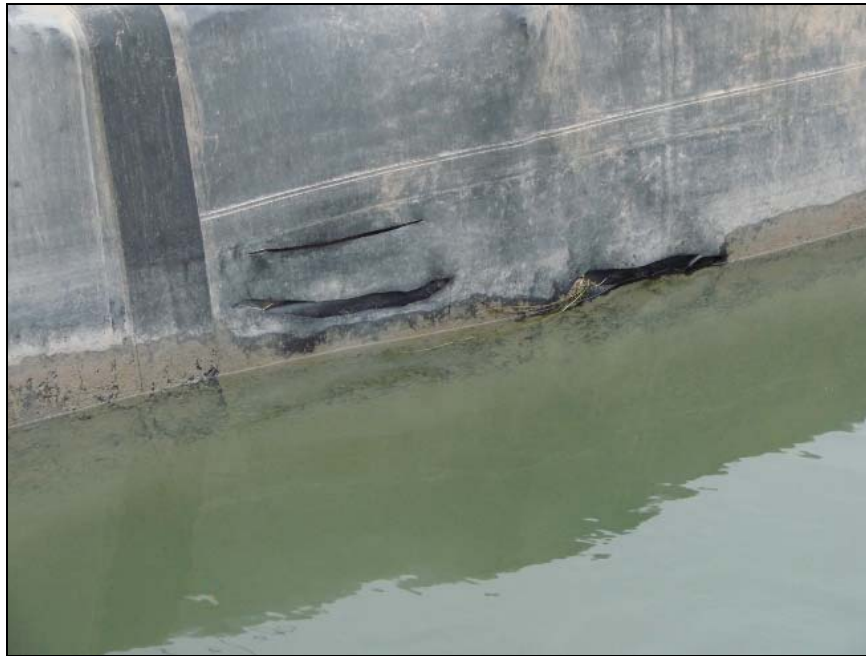
Most damage has occurred on the exposed areas of the liner and top side walls of the canal. Figure 18 shows a cut made with a sharp object (probably intentional vandalism) versus Figure 19 could have been a case of unintentional vandalism. In areas where kids are playing, swimming in the canals, or being mischievous, intentional and unintentional vandalism will occur. Vultures have been reported to pick at the seams on the EPDM Rubber; animal hoofs can cut some liners.

Figure 18. Horizontal cuts likely due to vandalism on the canal sidewall.

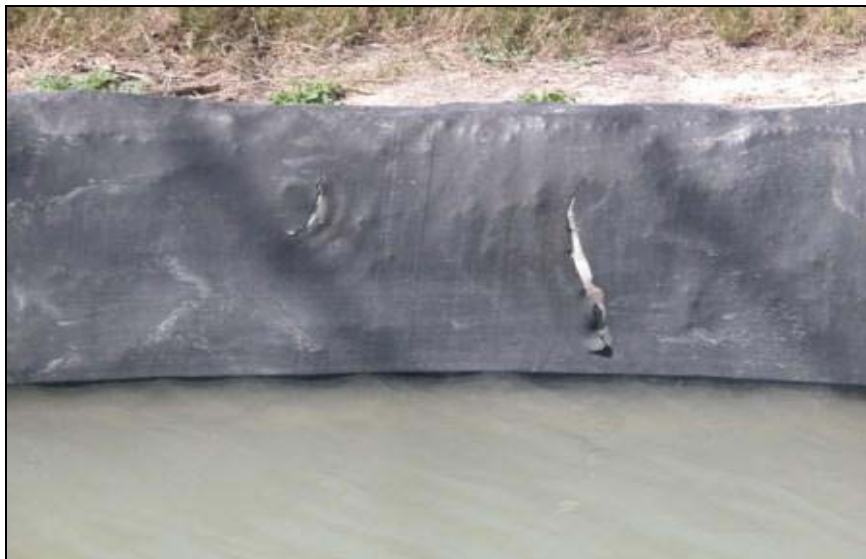
Figure 19. Vertical cut or tear on canal side wall caused unintentionally.

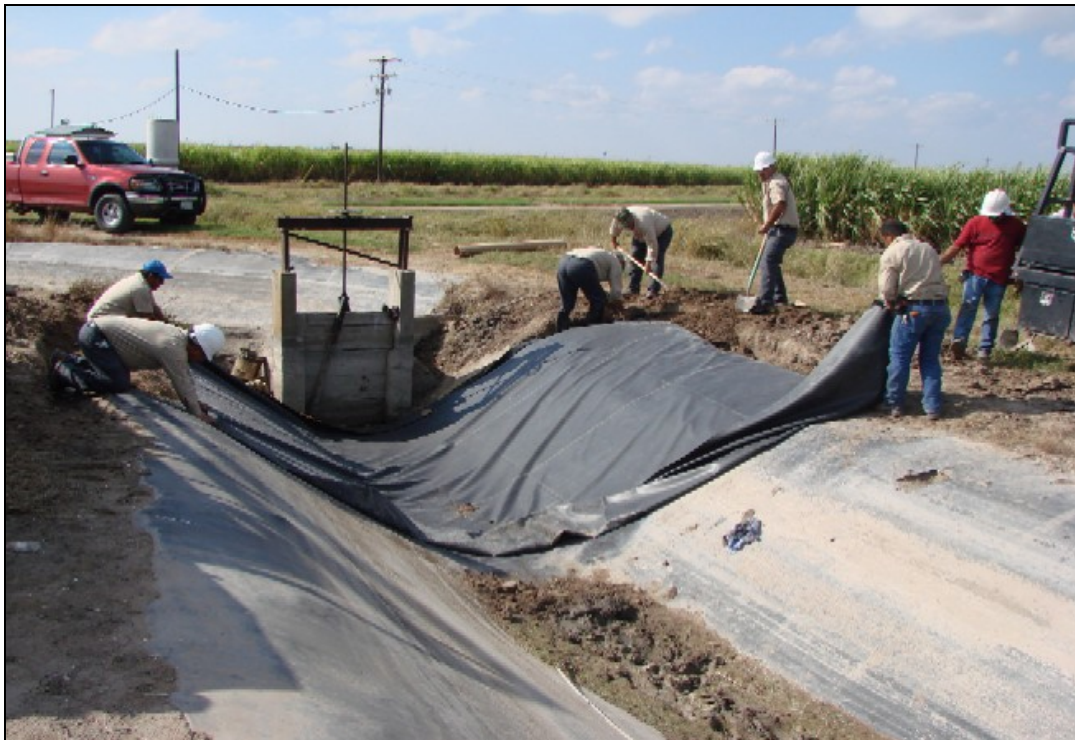
Figure 21. A district maintenance crew repairing a damage section of lining.

A regular inspection and maintenance program is important so that repairs can be completed on a time basis. Once a tear or cut starts, it will tend to expand or be susceptible to further damage until it is repaired. Districts should consider having their personnel trained to performed the repair and maintenance which sometimes requires specialized equipment, and similar glues and adhesives used during the installation process (Figure 21 and 22). Removing sediment from lined canals may be more difficult due to the limitations of using heavy machinery, and may require increased manual labor (Figure 23).

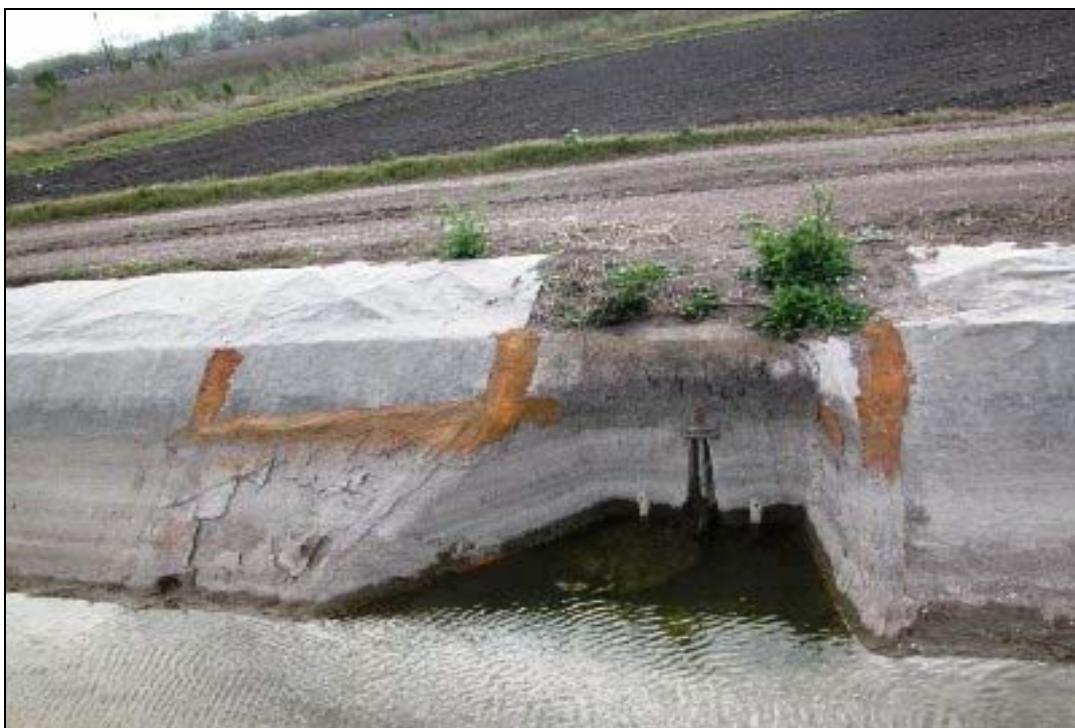
Figure 22. Repair of the liner joints around a structure with glue.

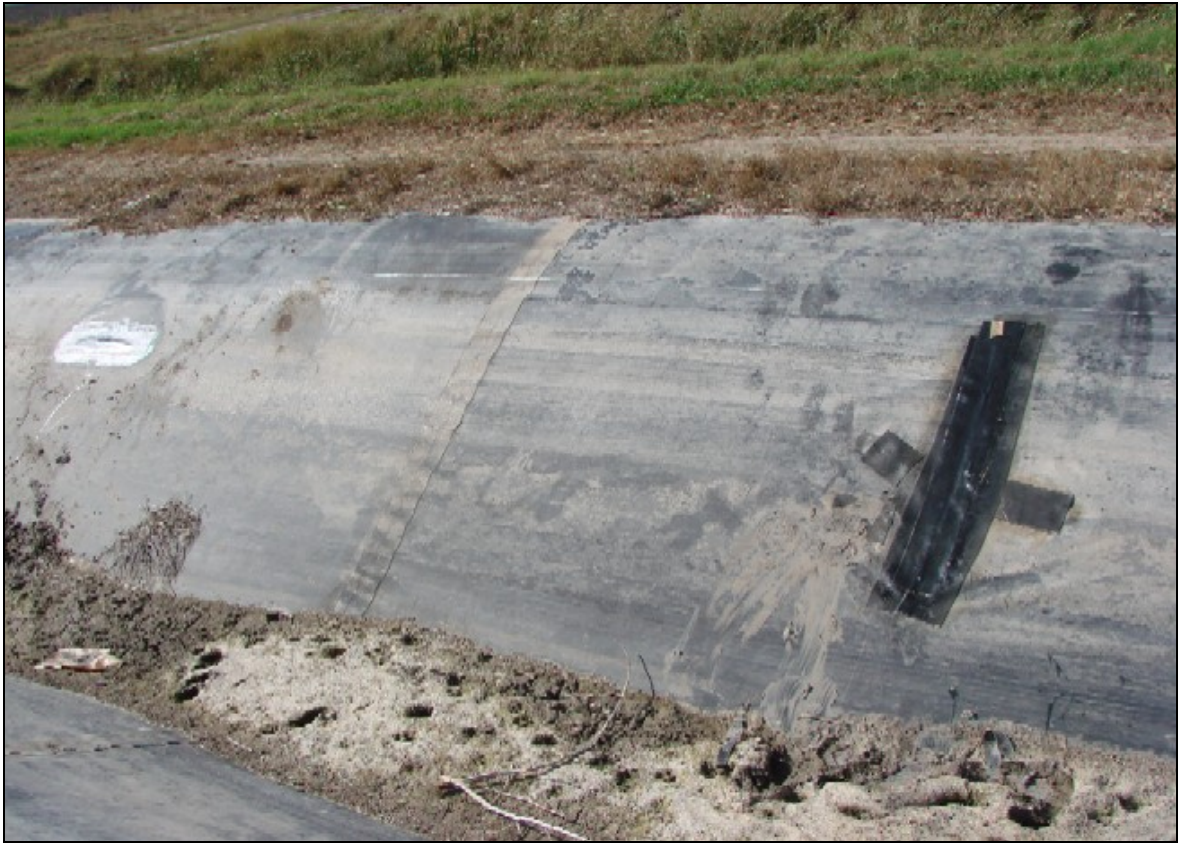
Figure 23. Sedimentation at the bottom of a lined canal.
