Seepage Loss Test Results in Cameron County Irrigation District No. 2

By:
Eric Leigh, Extension Associate and Guy Fipps, P.E., Extension Agricultural Engineer
Department of Biological and Agricultural Engineering, Texas A&M University, College Station,
TX.

Prepared for:
Cameron County Irrigation District No. 2

Texas Water Resources Institute Technical Report No. 375
Texas A&M University System
College Station, Texas 77843-2118

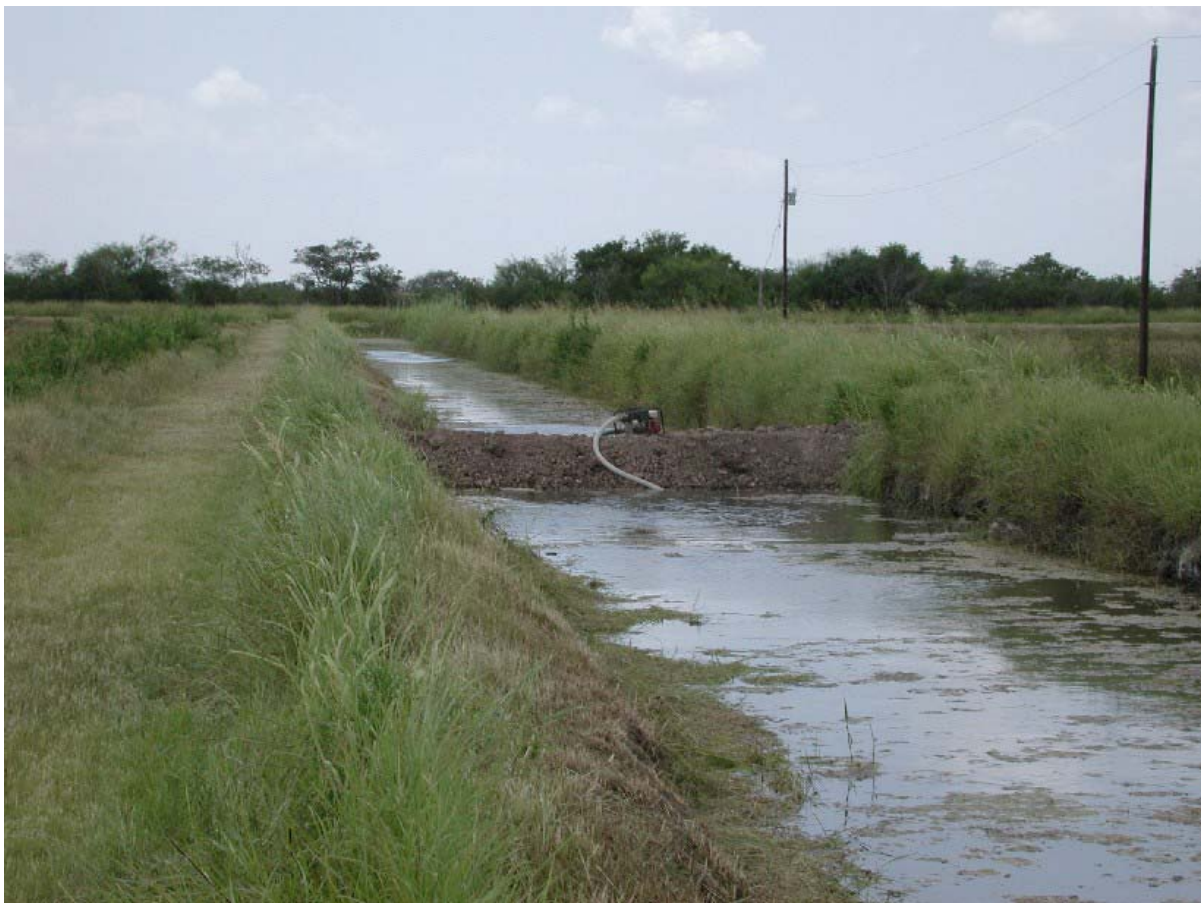
Figure 1. Earthen dam constructed on canal 55.

Loss rates were determined using the ponding method. In this method, the two ends of a canal segment are closed or sealed with earthen dams (Fig. 1), as are any valves or gates located in the test segment. Changes in water levels are recorded for at least 48 hours. One to three continuous-stage level recorders (Fig. 2) were used to supplement the 3 locations where stage levels were recorded manually. During the tests, canal dimensions and water span were also record and surveyed.

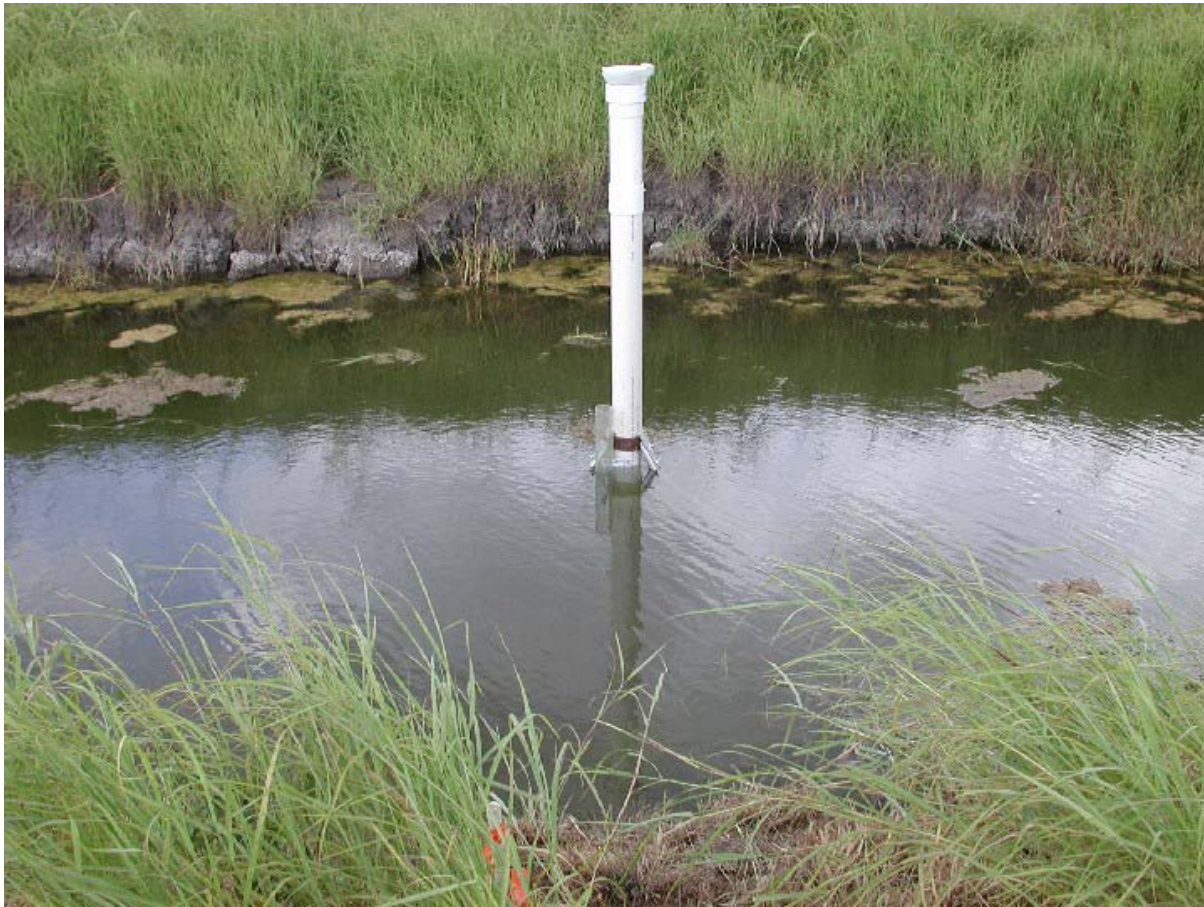
Figure 2. Continuous-stage level recorders on canal 55.

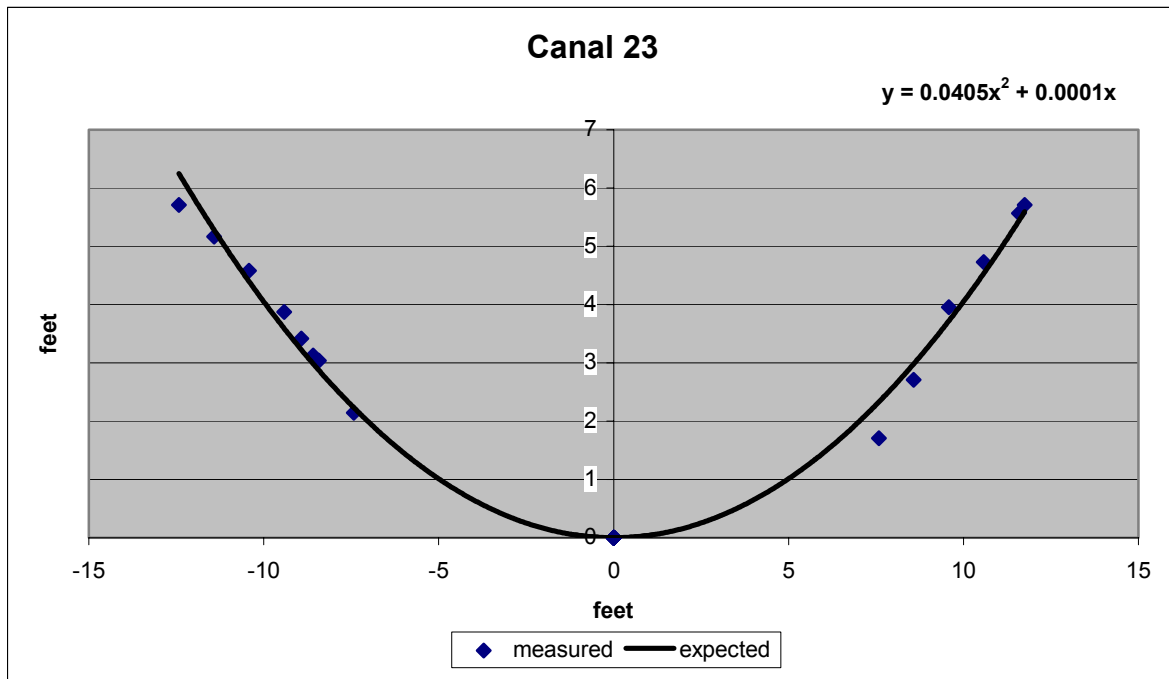
Figure 4. Cross-section of canal 23.

For each test segment, a chart is provided showing the measured canal profile compared to the expected canal profile. The expected profile was developed by fitting an equation to the measured data as shown.

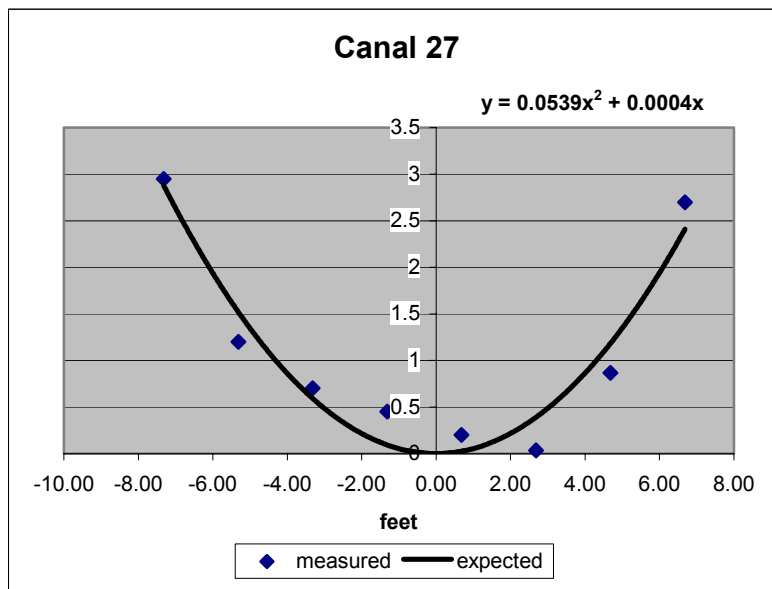
Figure 6. Cross-section of canal 27.

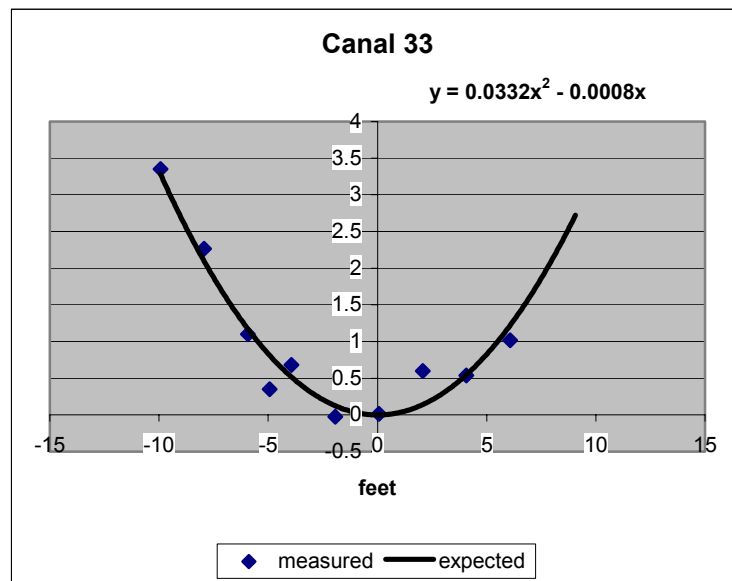
Figure 7. Cross-section for canal 33

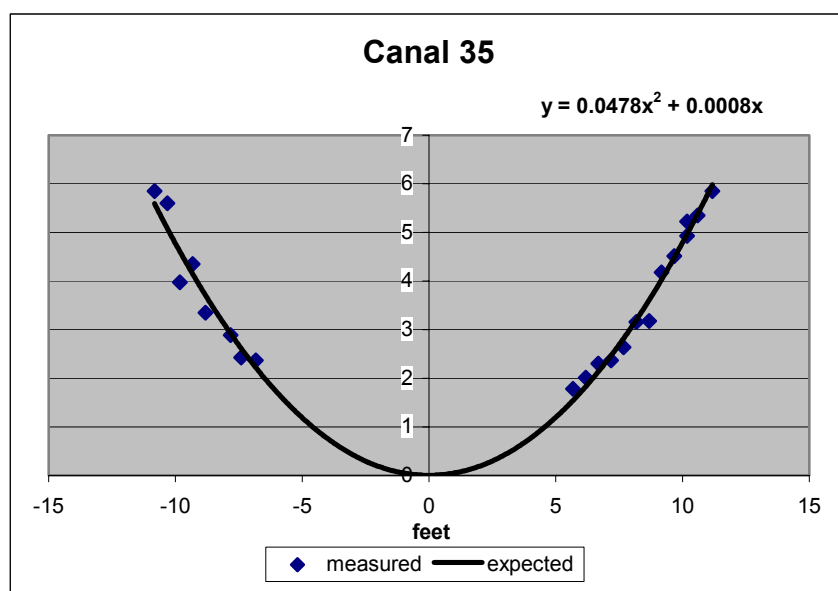
Figure 8. Cross-section of canal 35

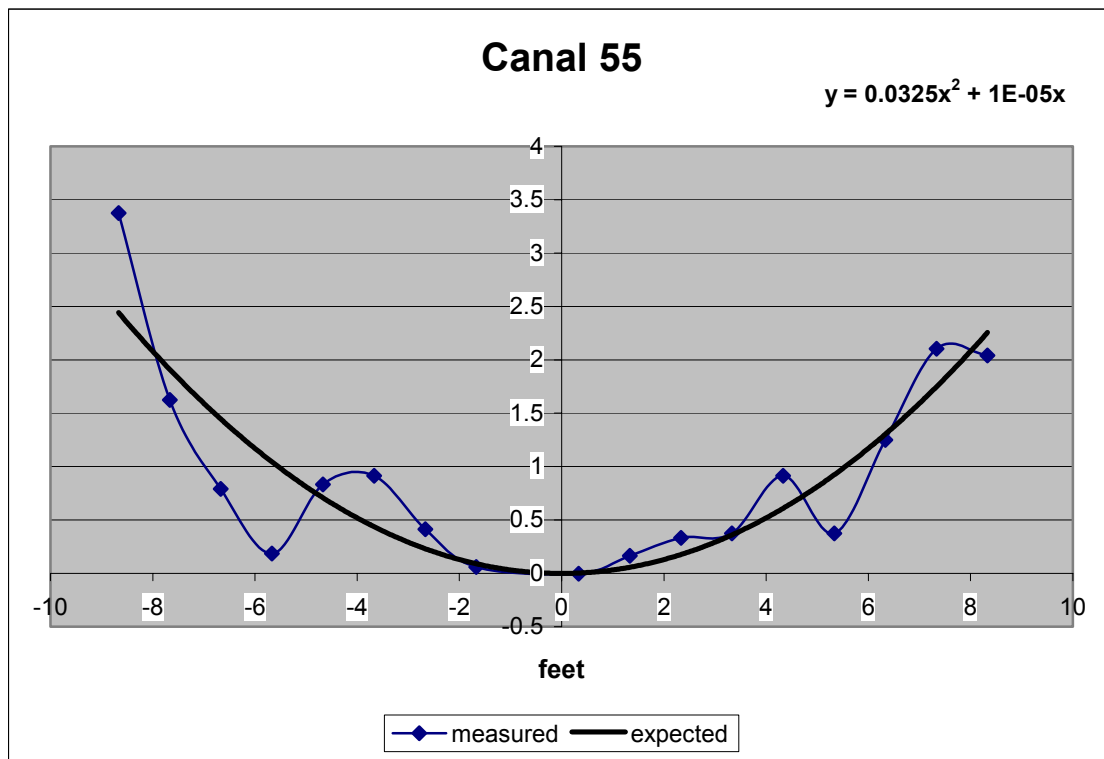
Figure 10. Cross-section of canal 55

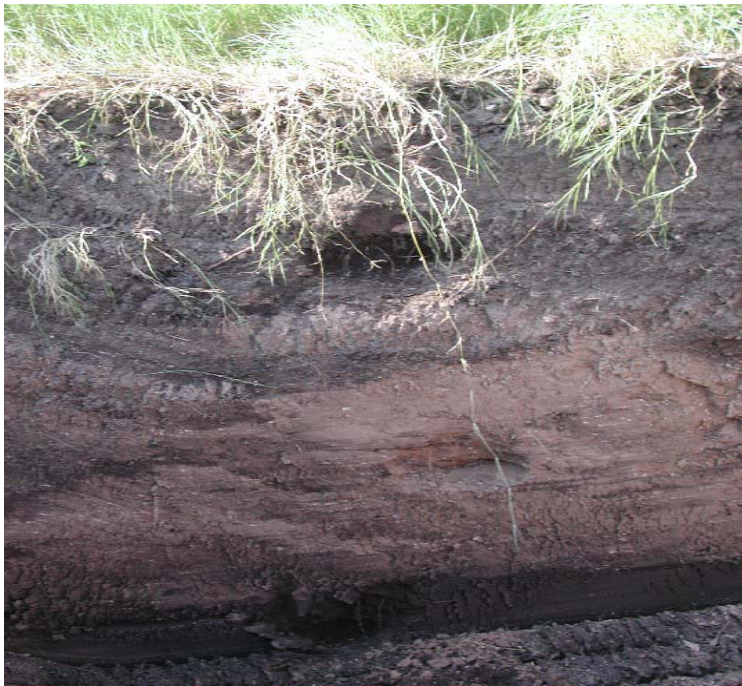
Figure 12. Canal levee soil profile on canal 23.

Two soil samples were taken of the canal embankment (or levee) and one in a field adjacent to the canal. One canal embankment (levee) sample was from inside the canal at or below the normal operating water level, and the other at a location approximately 10 ft from the edge of the canal and 2 feet below the surface. Natural surrounding soil samples were taken in fields adjacent to the test area down to 12 foot of depth. In these tests, shallow groundwater was not found within 12 feet of the soil surface.
