Evaluation of Canal Lining Projects in the Lower Rio Grande Valley

Texas Water Resources Institute Technical Report
July 2009

EVALUATION OF CANAL LINING PROJECTS IN THE LOWER RIO GRANDE VALLEY OF TEXAS

June 29, 2009

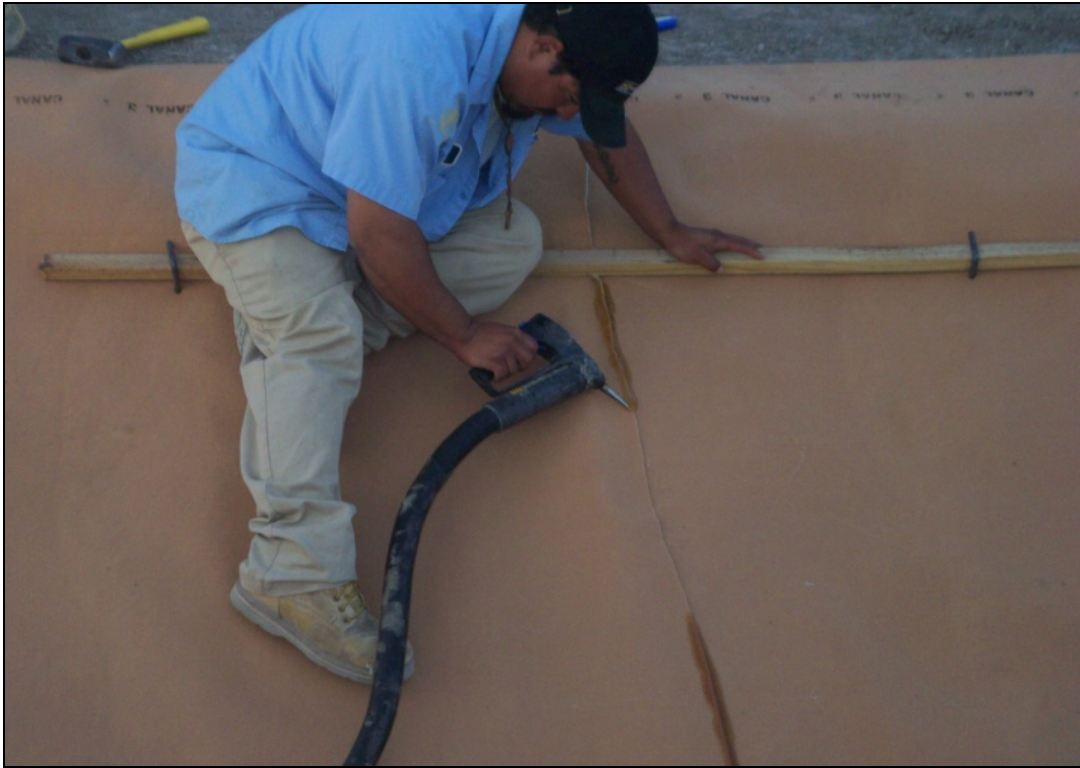
Liners need to be properly installed and stretched in order to prevent wrinkles. Wrinkles not only look unprofessional, but make the liner more susceptible to damage. Glues, liquid rubbers

resin, tar and types of metal pins are used to secure the material around the structures and at the joints (Figures 14 and 15).

Figure 14. Glues being applied to the joints of a polyester liner.

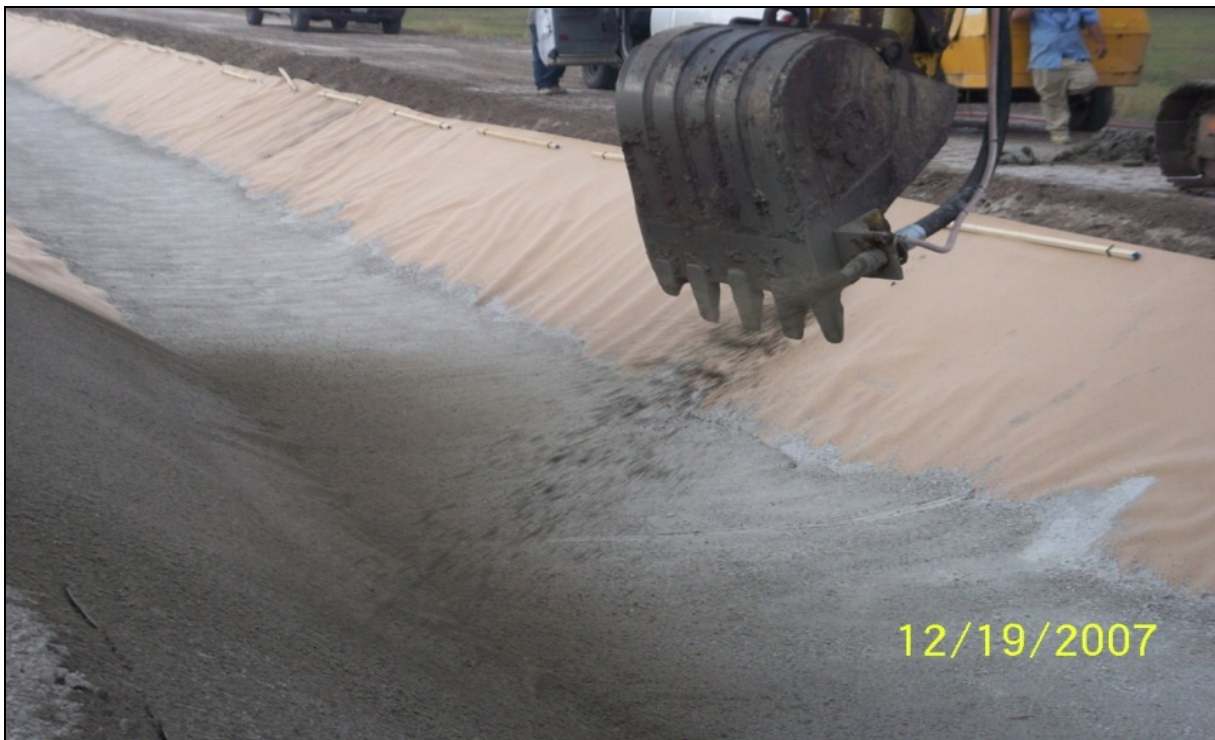
While the initial costs of a lining project using a use of a protective barrier such as shotcrete are higher, these costs may be offset by the reduction in costs of maintenance and repairs over the life of the project. An important consideration is the ability shotcrete to adhere to the liner. The polyester material has small fibers (similar to the harden side of Velcro) to which the shotcrete will stick when sprayed on to the liner (Fig.20). On the other hand, the PVC liner has a smooth texture to which the shotcrete will not stick, and a wire mesh needs to be used on the top of the liner to provide grip and added reinforcement. This application also increases labor and cost.

Figure 20. Shotcrete being sprayed onto the fibrous polyester liner.
